# WHOLE RIVER RESTORATION PLAN FOR THE RIVER KENNET AND RIVER LAMBOURN SSSI (2011)

# Executive summary

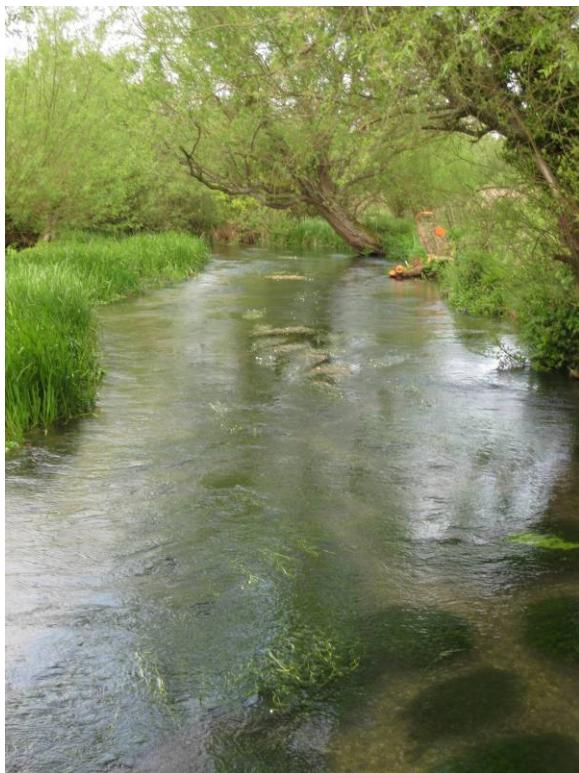
Photo 1 – ‘Natural’ River Lambourn at Weston

Photos 1-5 below show some of the features that could be considered to indicate good ecological health in the River Kennet and Lambourn (photo 1), the impacts of structures (2 and 4) and the benefits of removal and changes to sluice operation (3 and 5).

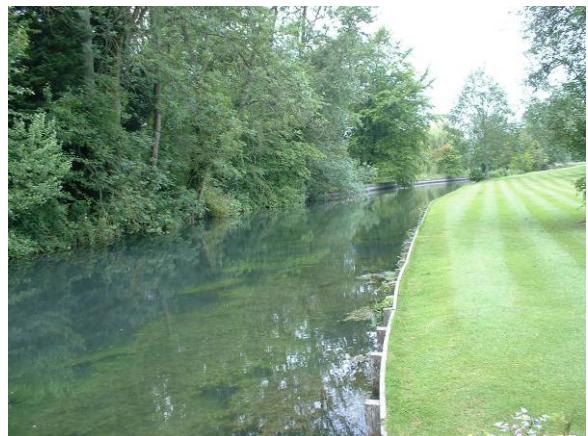
Photo 2- Impounded River Lambourn upstream of Woodspeen mill structure

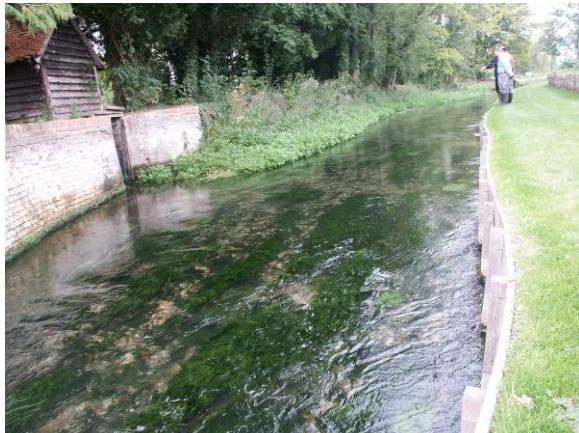
Photo 3 – Woodspeen Mill following structure removal

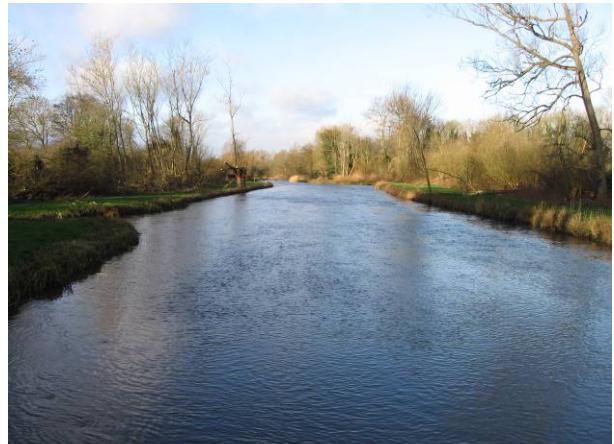
Photo 4 – River Kennet at Avington before restoration and change in sluice management

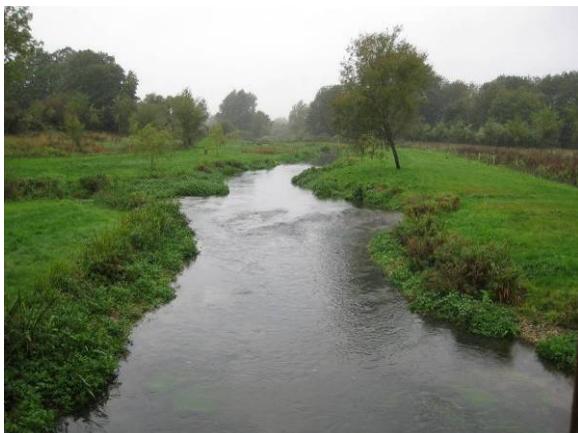
Photo 5 – River Kennet at Avington following restoration and change in sluice operation
