RIVER LAMBOURN, GREAT SHEFFORD

FISH PASSAGE & RIVER RESTORATION PROJECT

Project Summary - October 2025

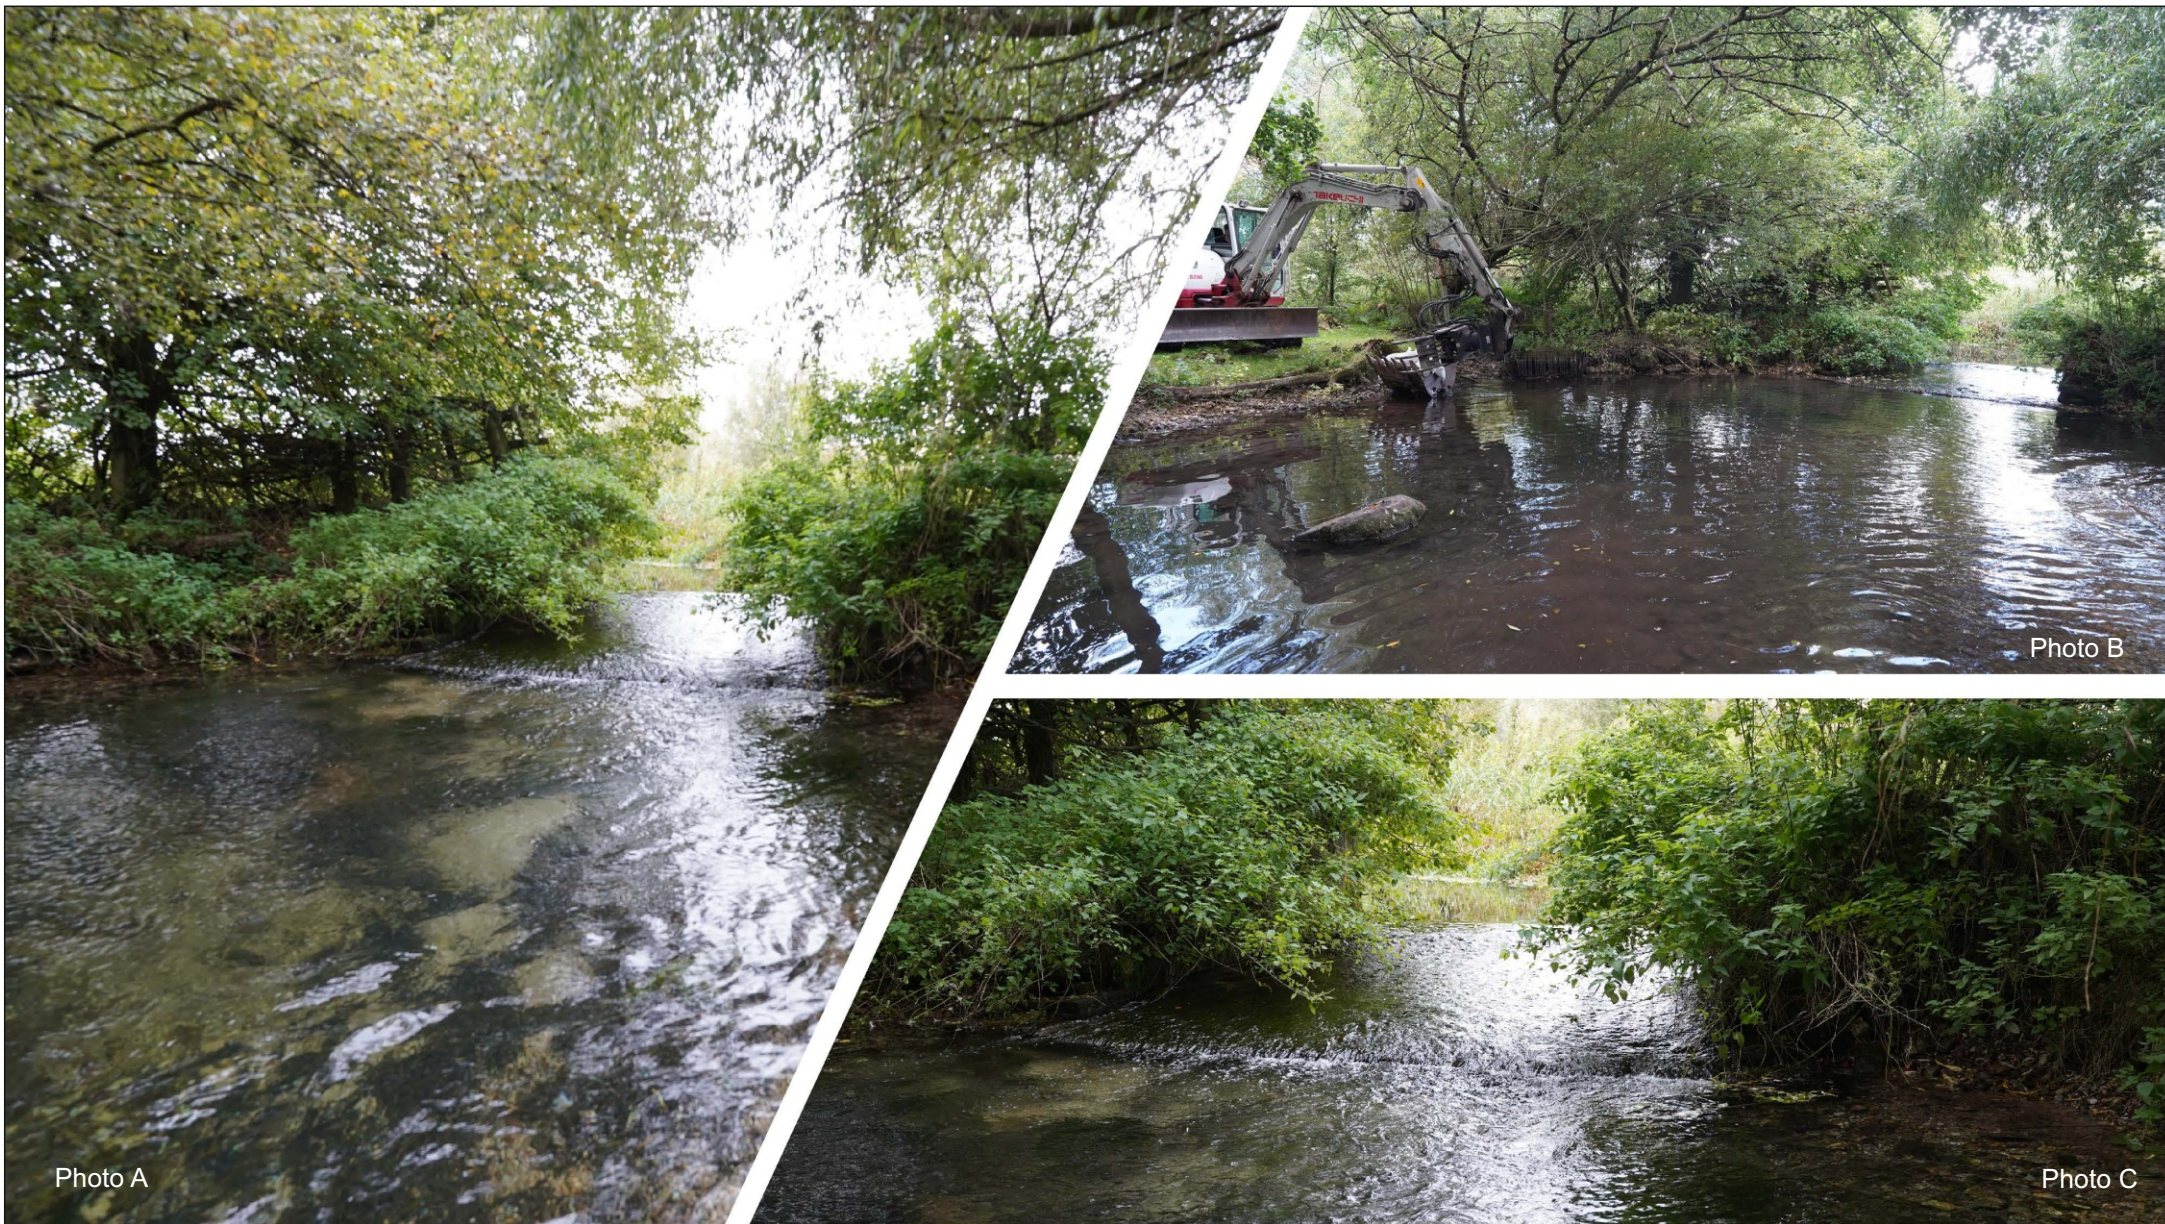
Photos A - C: The impounding flow control structure at Manor Farm is in a particularly sensitive location for fish passage, being located on the boundary between the perennial and winterbourne reaches of the river. Improving fish passage at this location will have a beneficial impact on fish populations and the ecology of the river. For winterbournes to function well for fish communities, the temporary reaches upstream of this weir need to be effectively and naturally connected to the perennial reaches downstream.

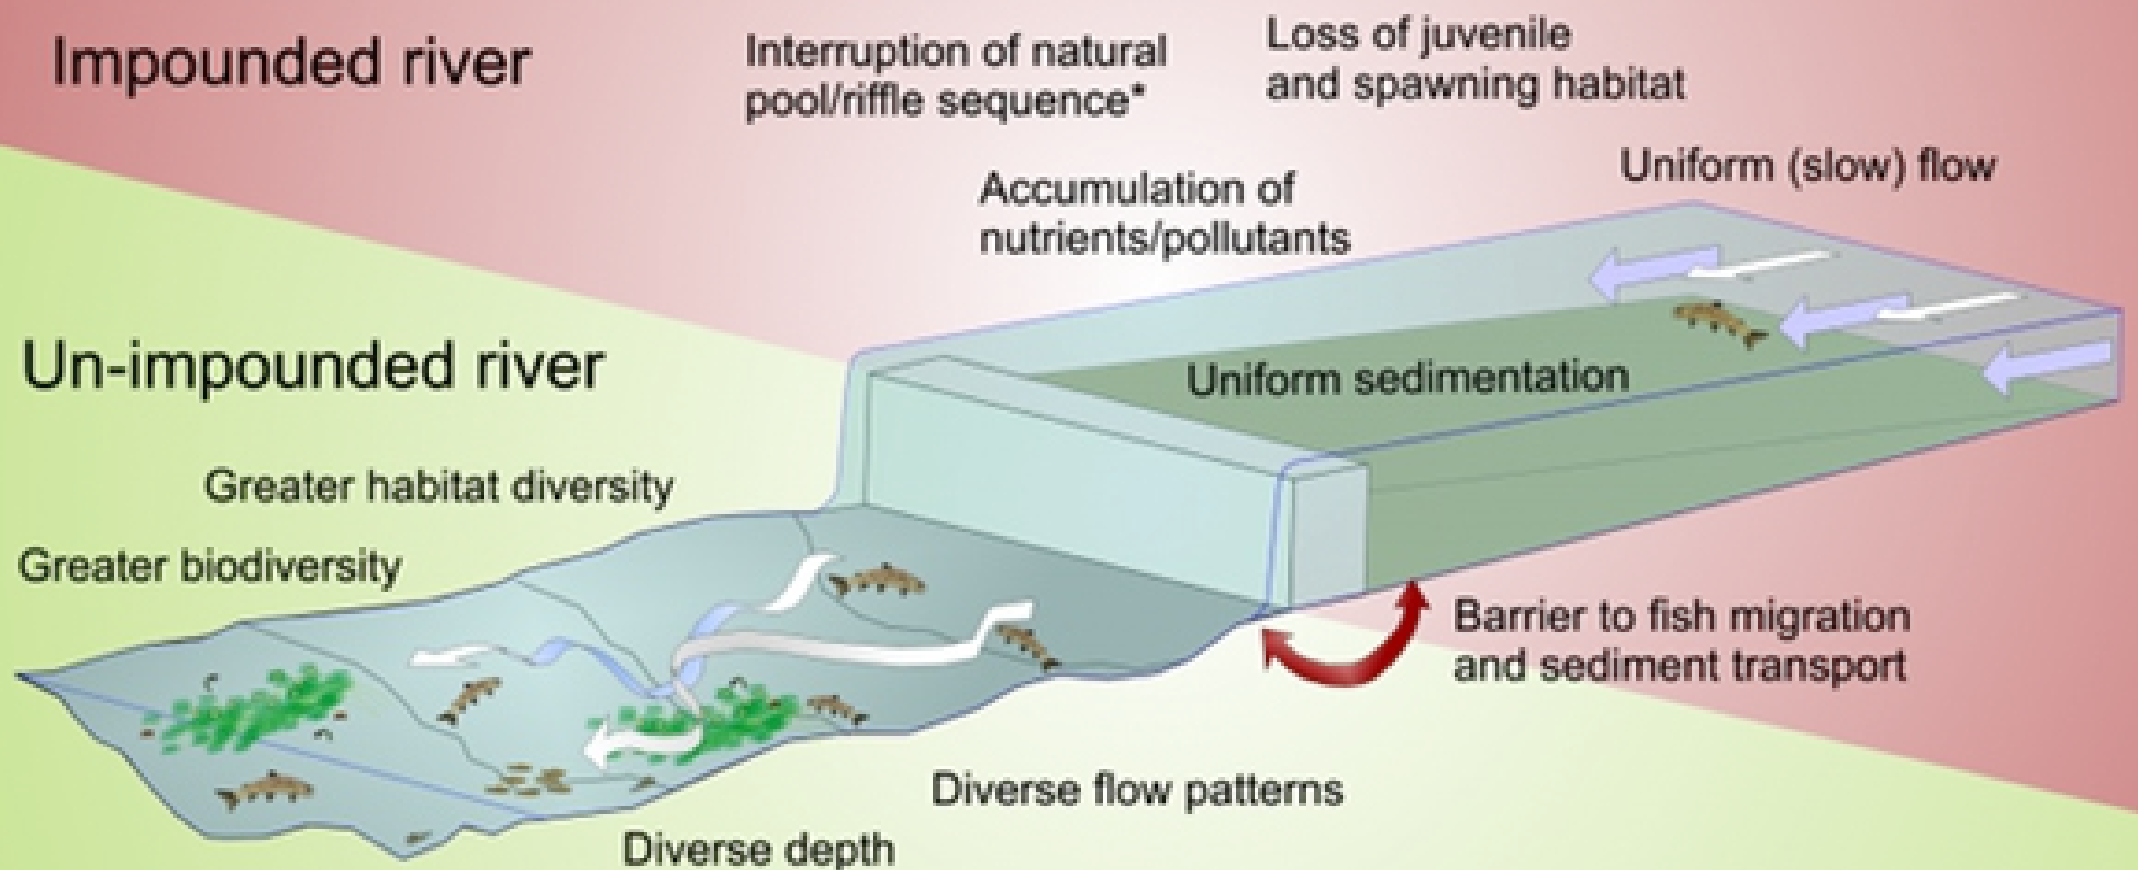
*Impoundments often create 'weir pools' downstream which provide holding habitat but at the expense of naturally-formed pools and riffle habitat

Figure 1: Wild Trout Trust illustration of the impacts of how the impounding flow control structure at Manor Farm has been impacting channel habitats and fish migration.

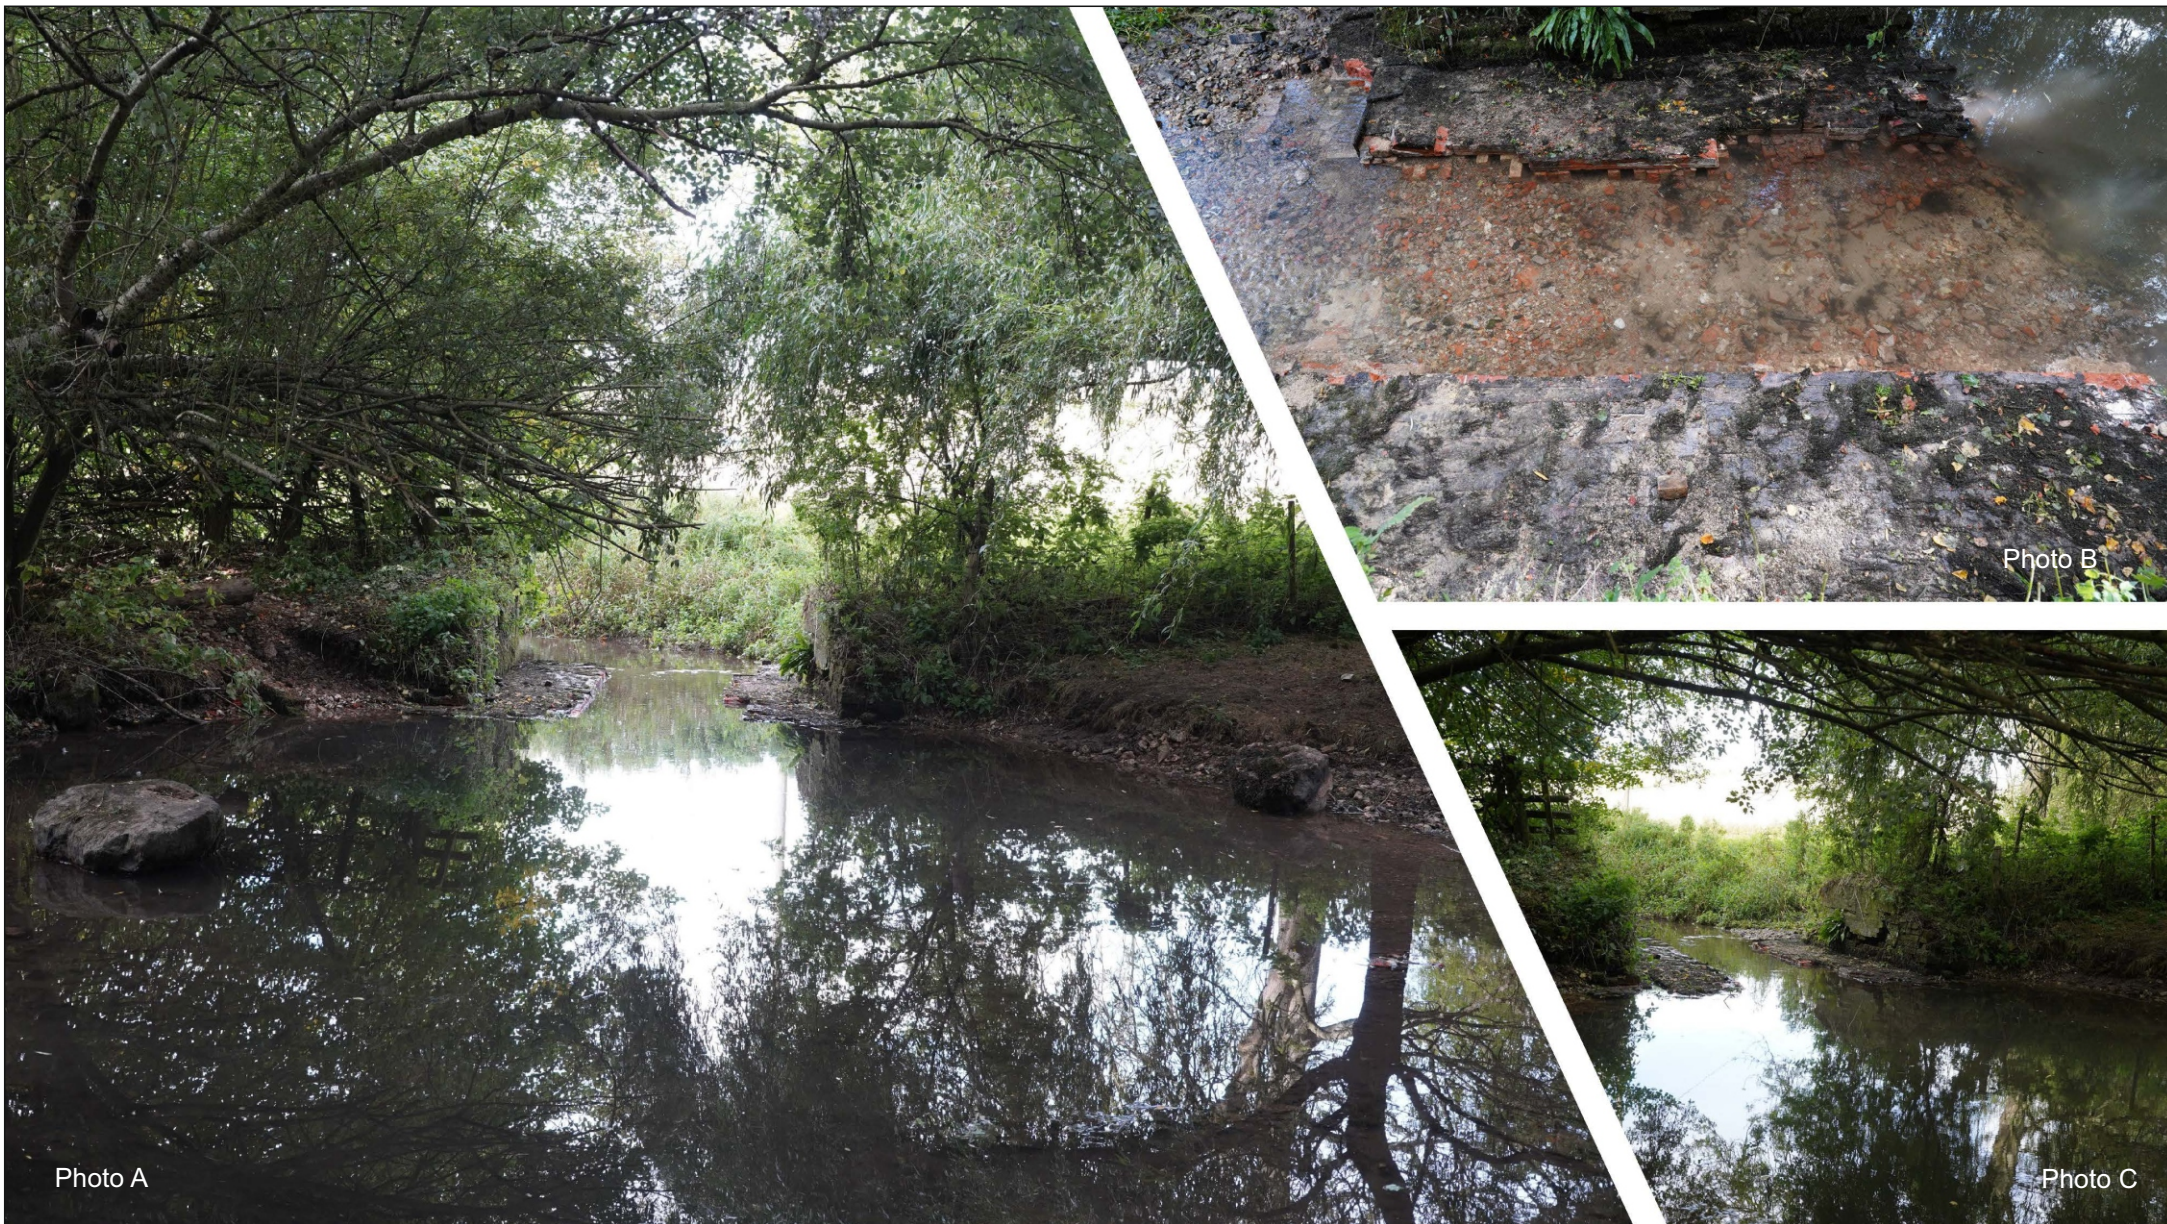
Photos A-C: Structure after notch made (September 2025). Fish observed moving upstream and downstream through the notch immediately after works completed. The notch has also reduced the impounding effect of the structure and has exposed a gravel riffle upstream that had previously been drowned out by the impoundment.

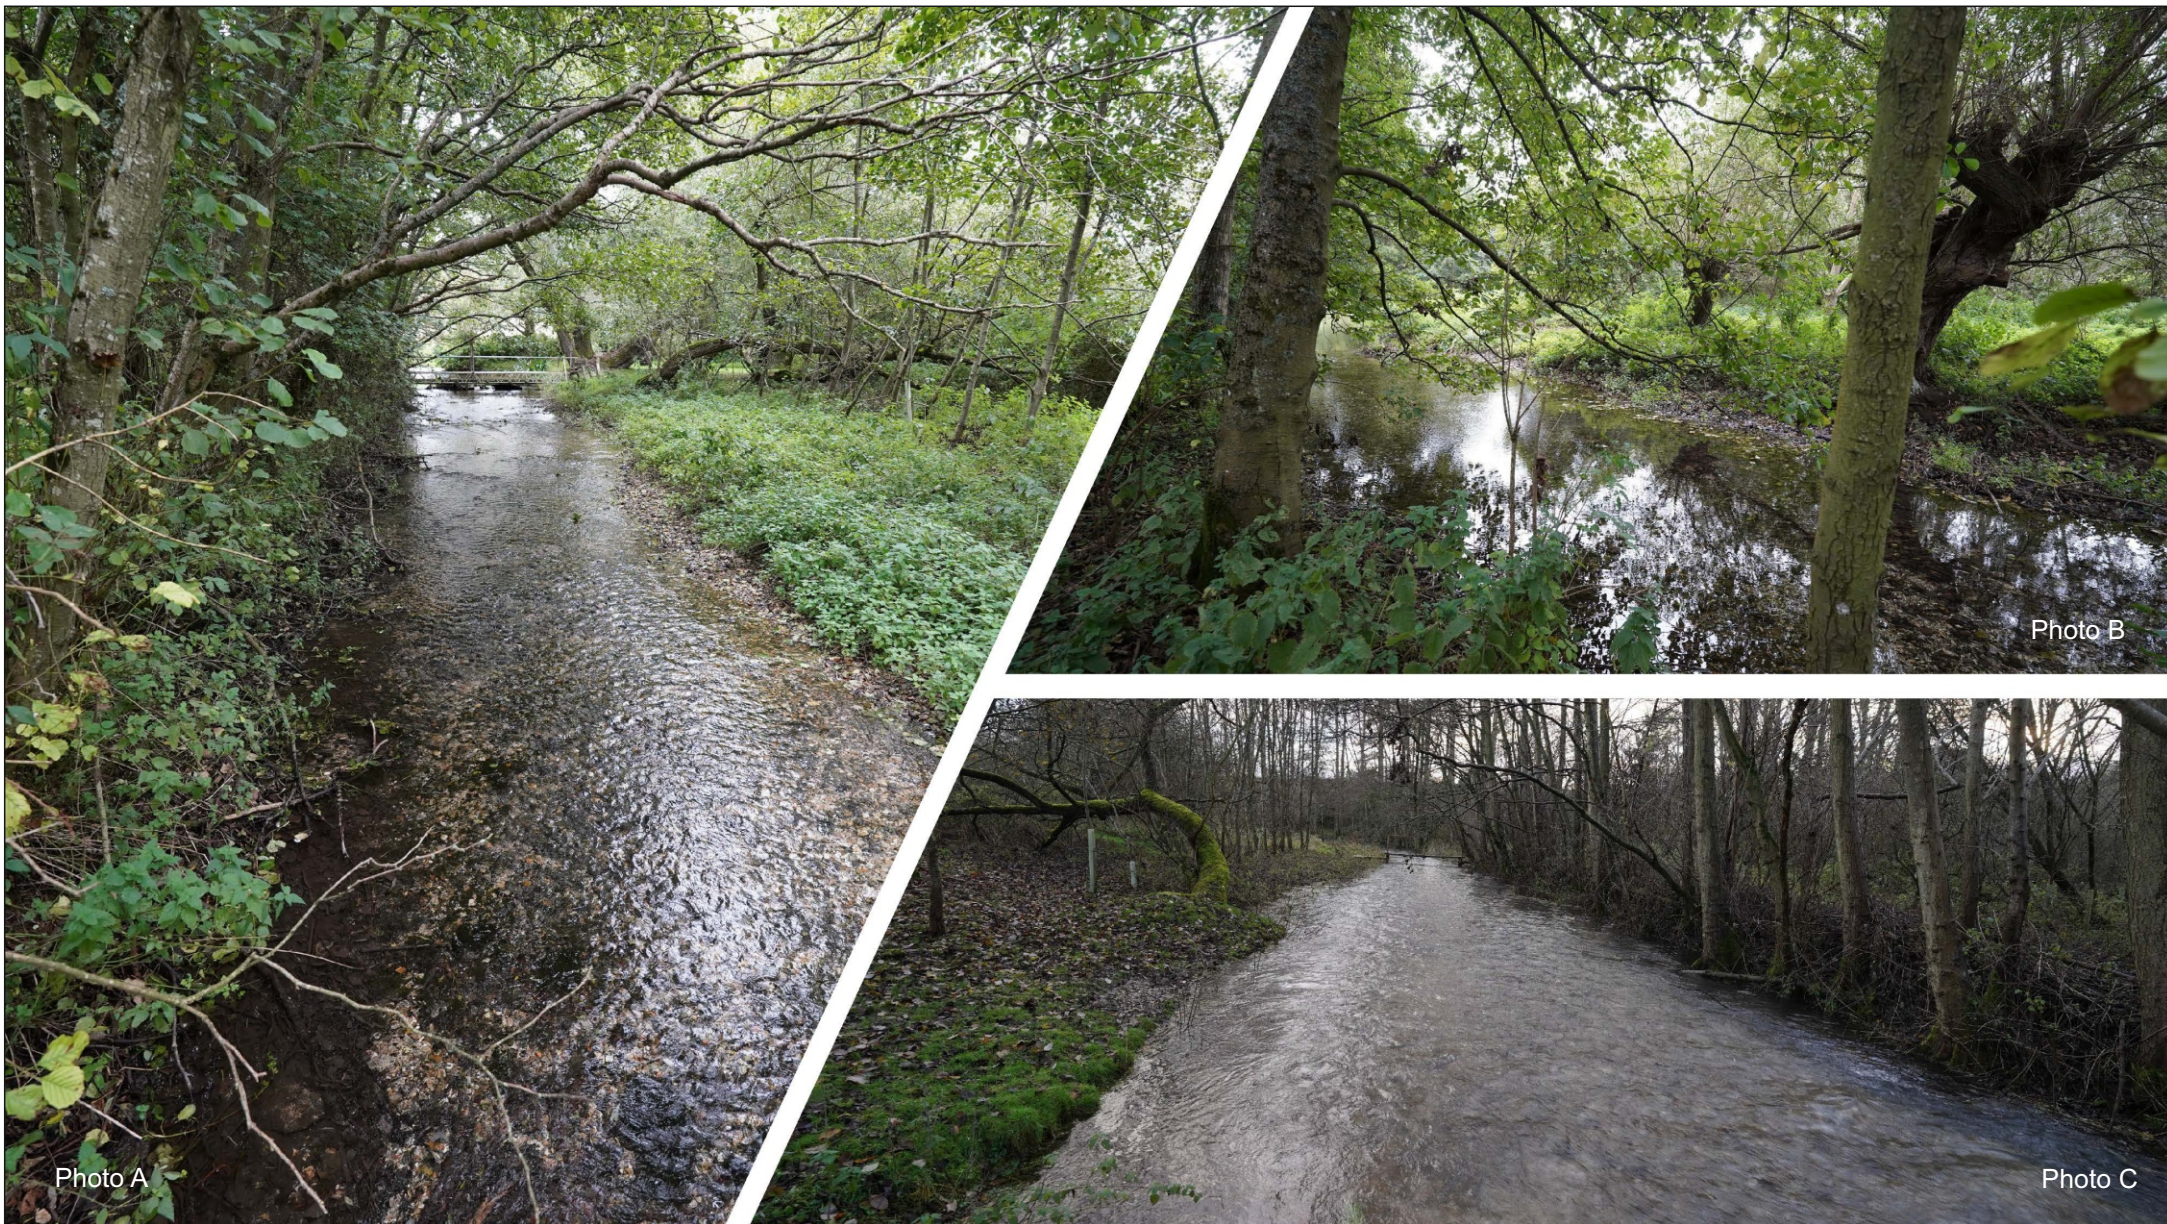
Photos A: Straight and over wide reach downstream of the weir pool. Heavily shaded by uniform stand of Alders.

Photo B: The lower end of this reach also over wide and over shaded.

Photo C: High flow conditions in winter 2023.

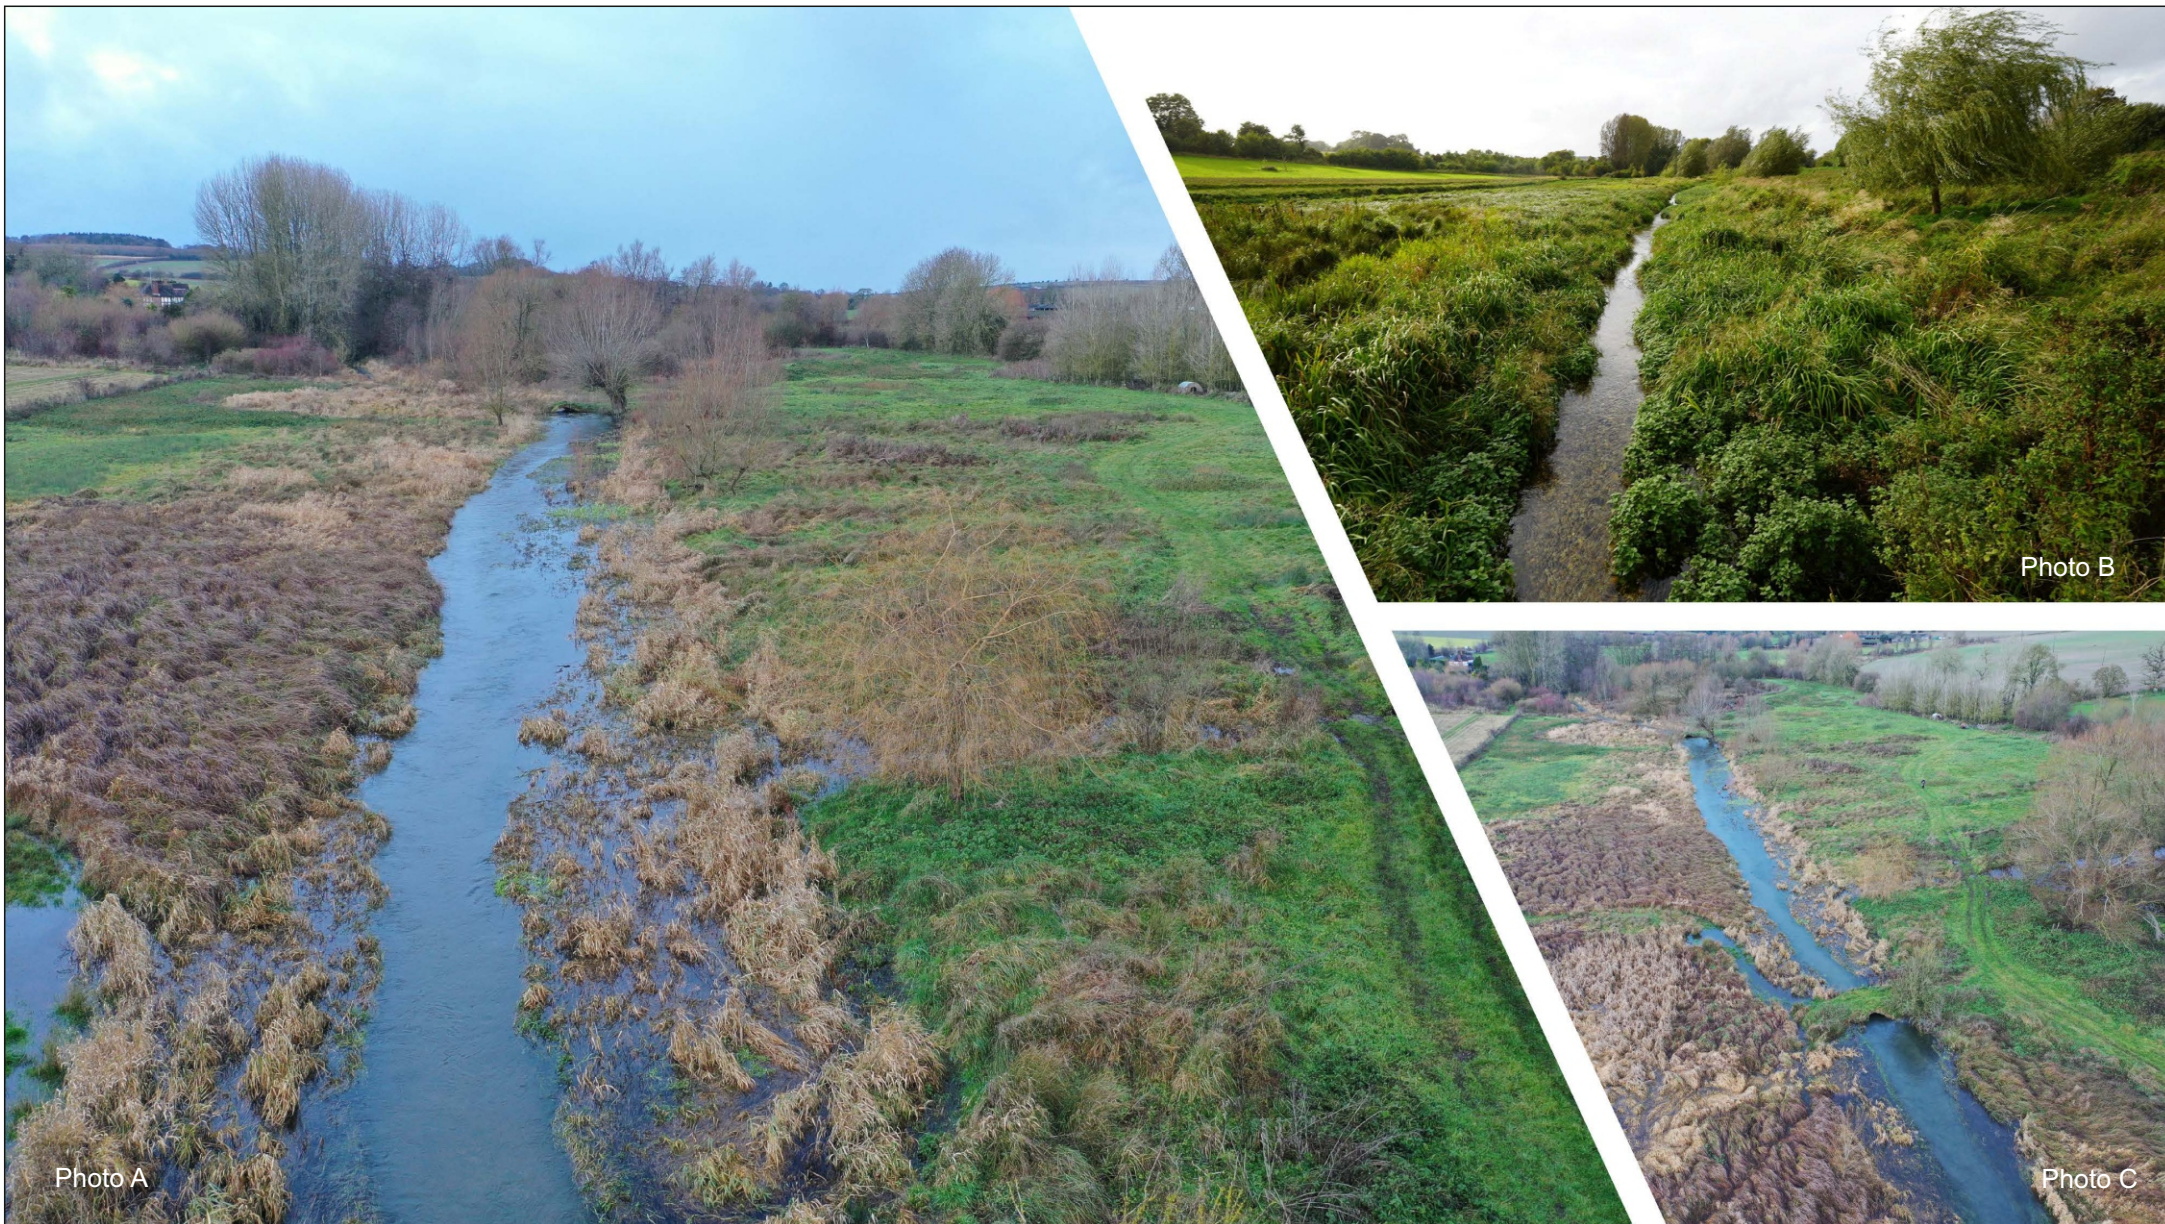
Photos A-C: The middle reach (under high and low flow conditions) before works carried out. Historic modifications have created a straight and uniform reach of channel. Over-grazing by previous owners also caused the channel to become over-wide and devoid of bankside trees and in-stream cover. The existing light touch management has allowed the river to begin the process of self-repair with the colonisation of marginal plants helping to restore more natural channel dimensions and supporting a far more diverse riparian zone. The proposed works aimed to improve in-channel habitat diversity and floodplain connectivity.
